Reducing Measurement Error in Wet Magnetic Particle Inspection in Steel Castings

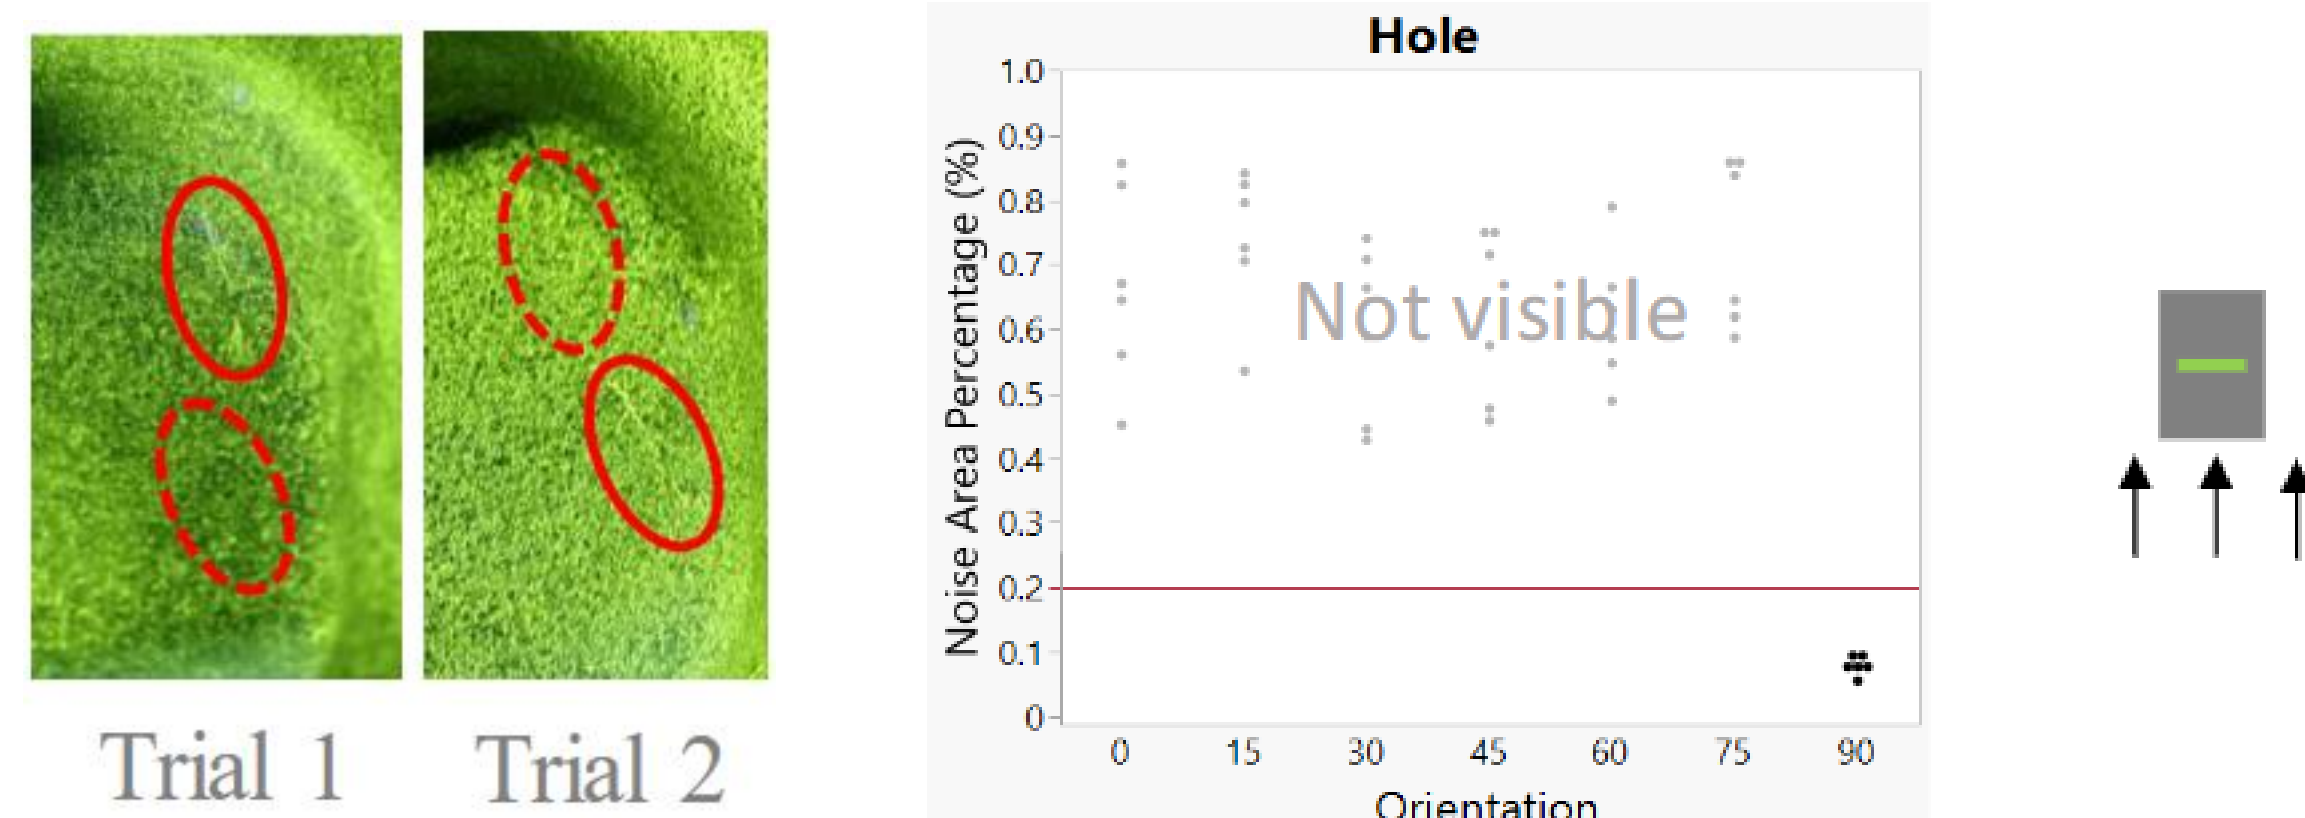
Problem Statement: A gauge repeatability & reproducibility (R&R) study across 4 foundries showed poor results (70% escape) in the MPI process which reduces the likelihood of creating reliable castings

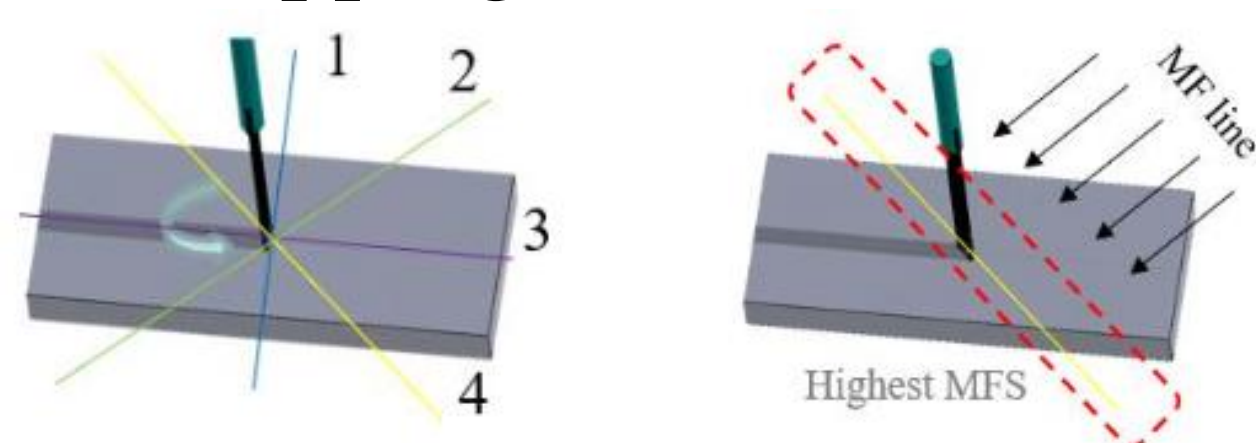
- Orientation mapping

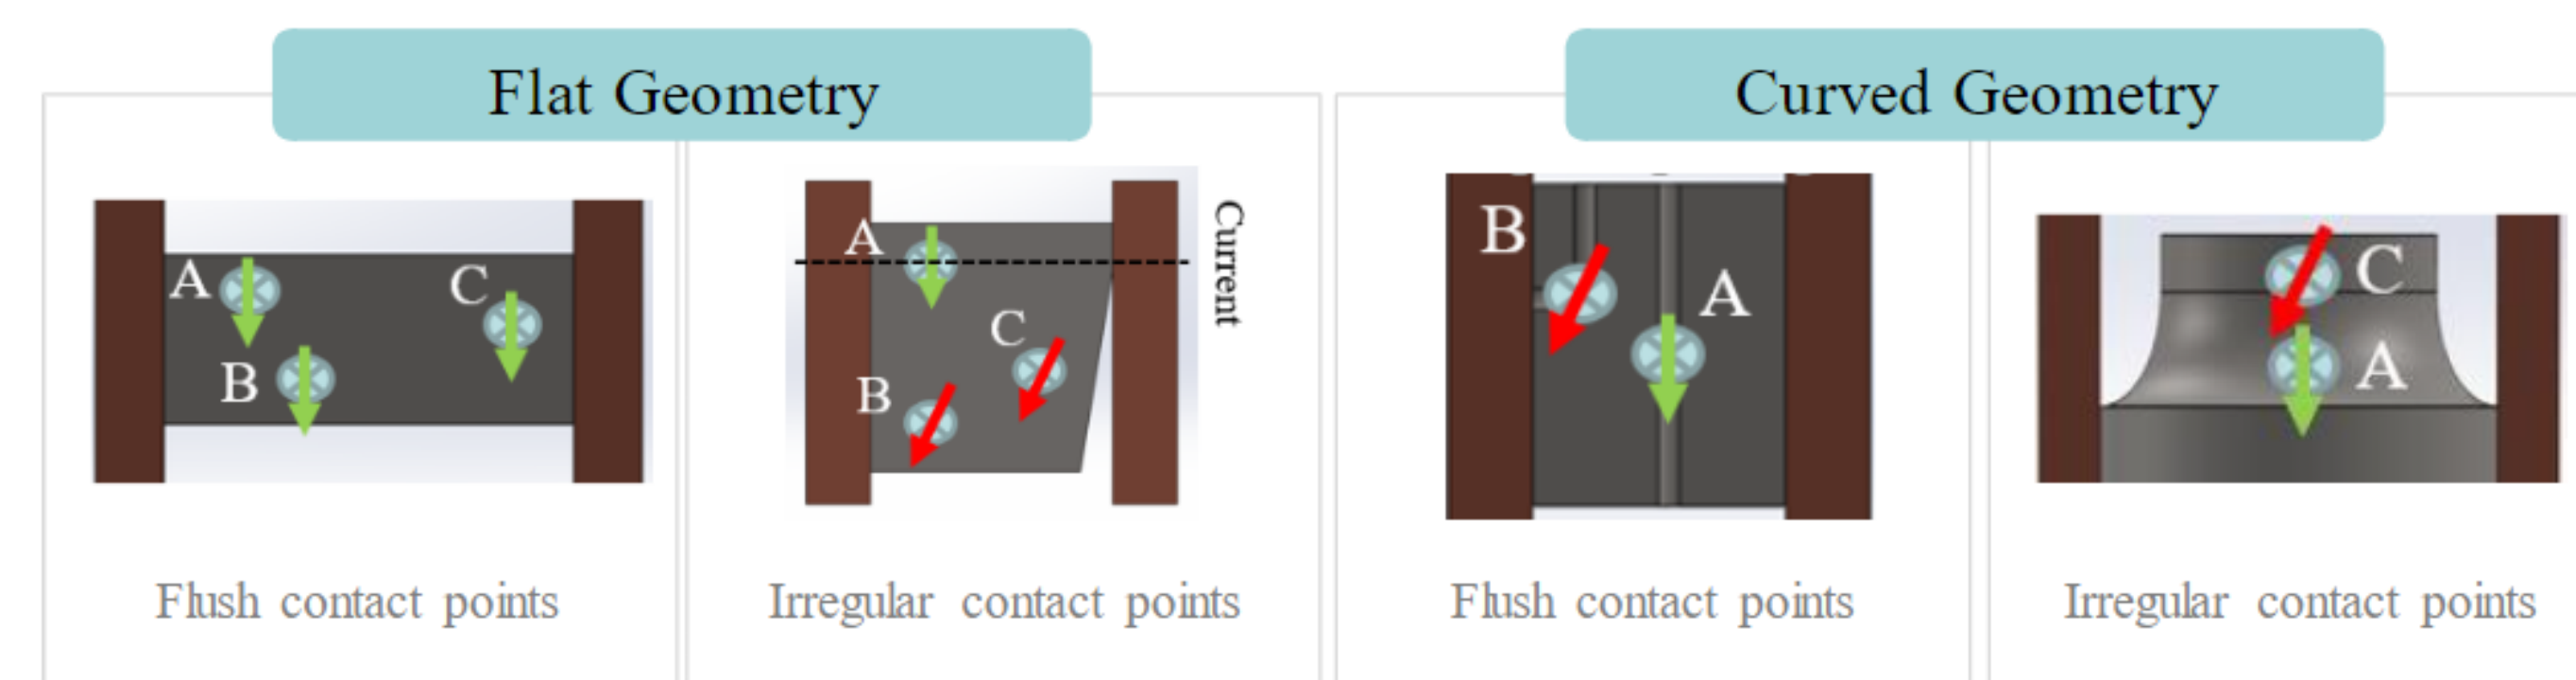
Orientation mapping

- Only flat & flush contact had results as expected for all points

- Castings have complex geometries
- This study shows field direction is dependent on geometry
- This work could lead to design recommendations to optimize defect detection

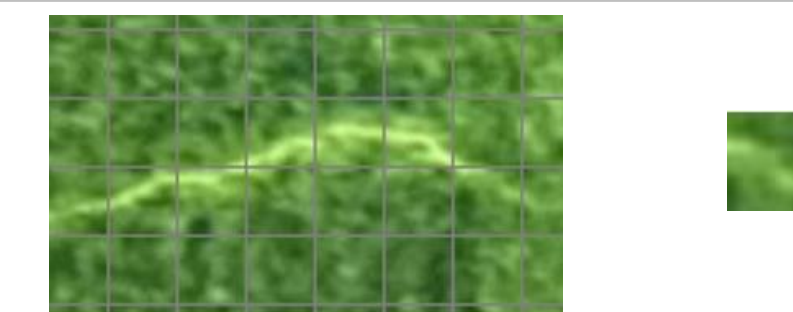
- Proposed grid style labeling method for cracks
- Most other objects need whole bounding box for context

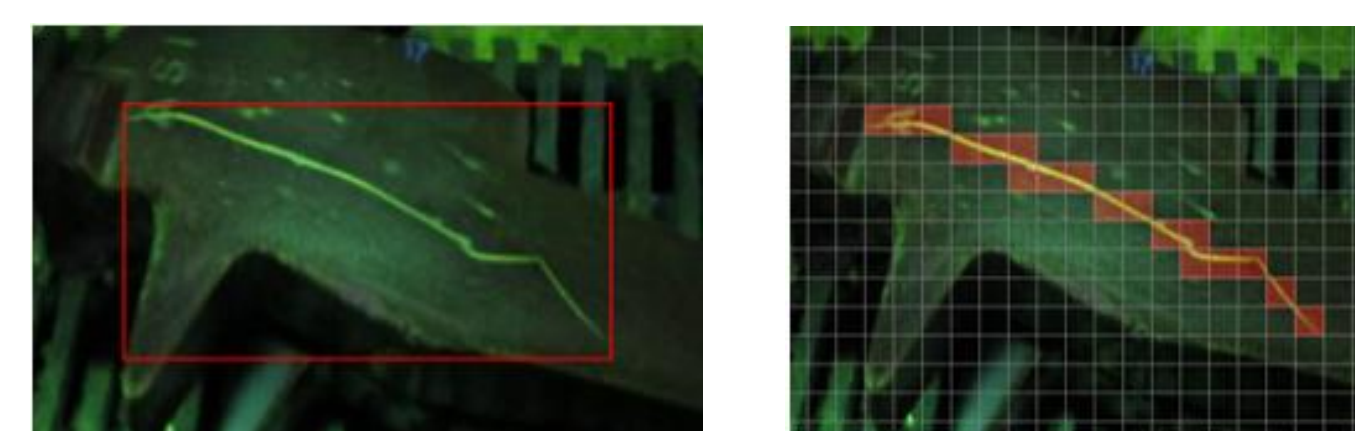
Advantages of grid style

- Faster
- Less background

- **Grid style reduced the escape rate of defects to 13%**

- Grid style labeling reduced escape rate to 13%
- Currently, the model itself performs better than the human operator
- Foundries will be able to produce higher quality castings using this solution

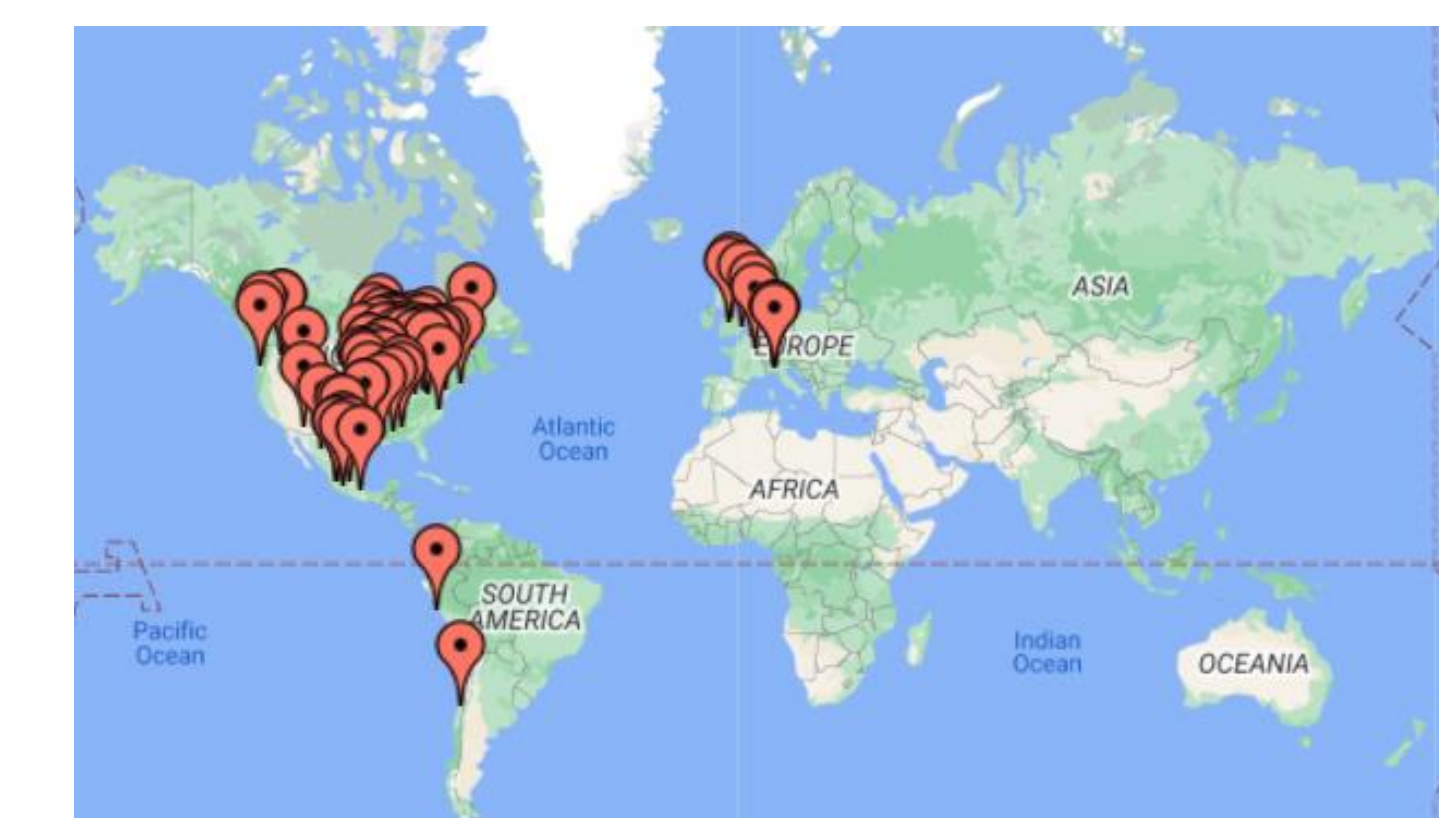
Videos

- The MPI videos help foundries globally reduce measurement error in wet MPI

✓	Video 1: Introduction
✓	Video 2: Bench Setup
✓	Video 3: Testing Efficacy
✓	Video 4: Running an Inspection
✓	Video 5: Identifying Defects
	Video 6: Post-Inspection
	Video 7: Conclusion
